## ■ Reflectivity Change after 1 min of Processing

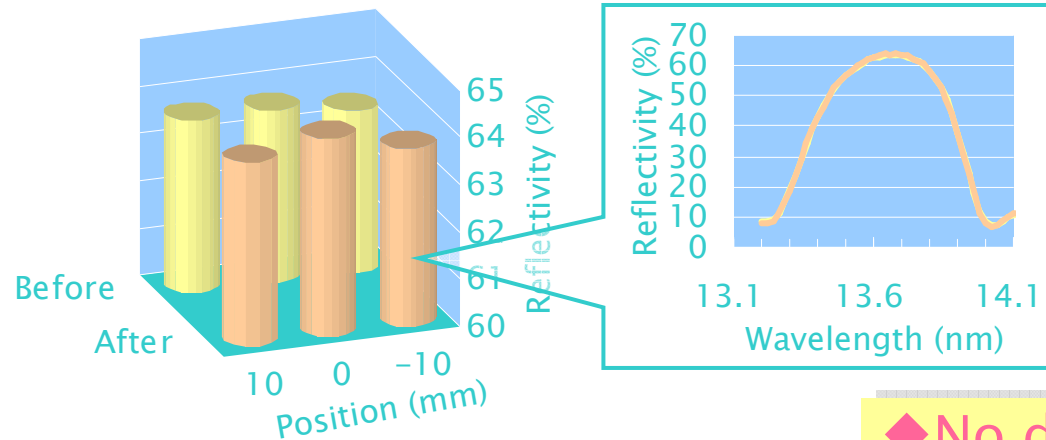
### ● Si capped ML

Correspond to 70~80 nm of carbon film removal.

before	after	diff.*
Processed	63.6 %	64.0 %	+0.4 %
Reference	63.6 %	63.7 %	+0.1 %

◆ No degradation was observed.

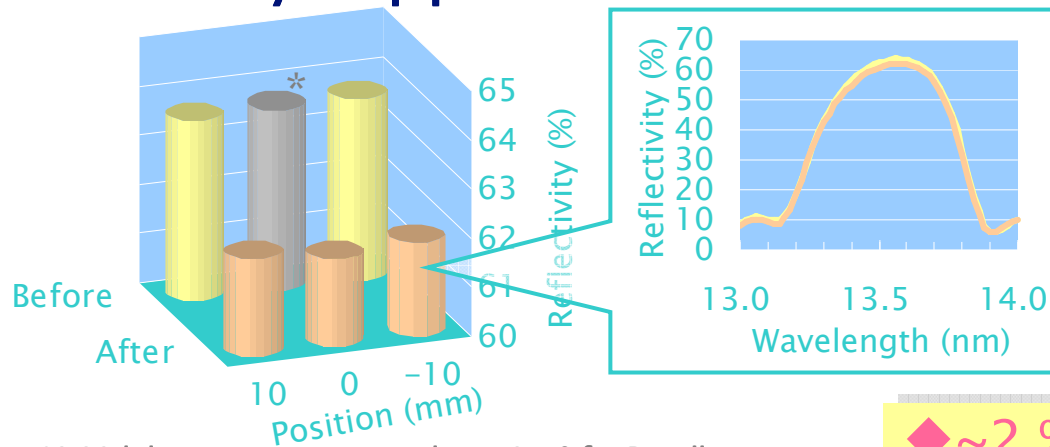
### ● Ru-alloy capped ML

before	after	diff.*
Processed	63.7 %	61.9 %	-1.8 %
Reference	-	63.4 %	-

◆ ~2 % of reflectivity down.
